1842 EEG/EEIS TR 79-2

INDUCED VOLTAGE/LIGHTNING PROBLEMS
AT
USAF BRANDYWINE AND DAVIDSONVILLE SITES

SUPPORT ENGINEERING BRANCH
1842 ELECTRONICS ENGINEERING GROUP (AFCS)
SCOTT AIR FORCE BASE, ILLINOIS

19 January 1979

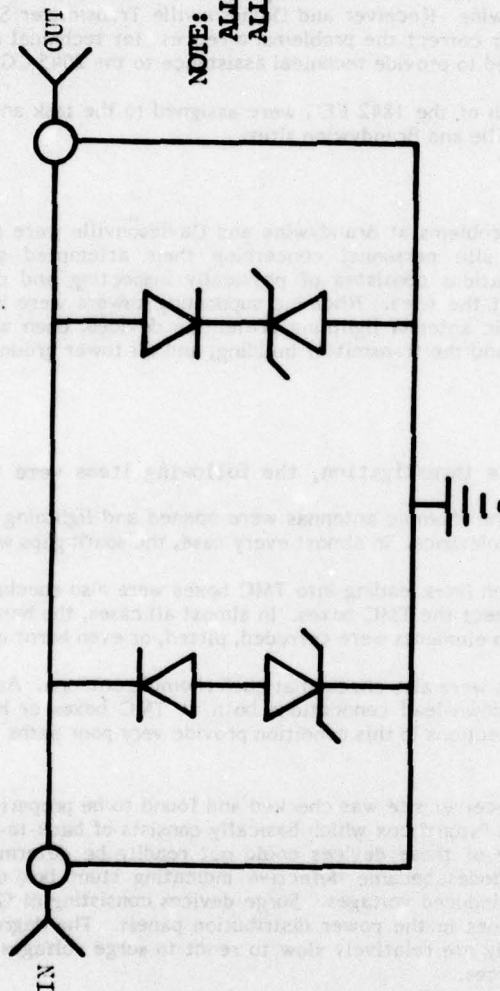
FIGURE 1. RF OVERLOAD ASSEMBLY (STUNT BOX)

3.1.4 The RF cable entry plate at the receiver site was checked and found to be properly grounded. RF inputs to the multicouplers were protected by a "stunt" box which basically consists of back-to-back diodes and zener diodes (see Figure #1). The adequacy of these devices could not readily be determined; however, during lightning storms, some of the zener diodes became defective indicating stunt box operation and possibly providing some type of protection from induced voltages. Surge devices consisting of GE home type lightning arresters were installed on the power lines in the power distribution panels. The degree of protection these devices provide is questionable since they are relatively slow to react to surge voltages and therefore provide inadequate protection for solid state devices.

4.1.5 Additional surge protection devices should be installed at TMC boxes and at the RF multicoupler inputs. These devices are listed in Figure #3. Devices to be installed in the TMC box will be prototyped by the 1842 EEG. Recommend that the initial installation be coordinated with NCA and the actual installation be witnessed (and engineering assistance provided) by the co-authors of this report. It is also recommended that a ground rod be carefully driven directly outside and opposite the cable entry plate at the receiver site and the plate connected to the ground rod. The new ground rod should provide a more direct path to ground for existing RF cables.

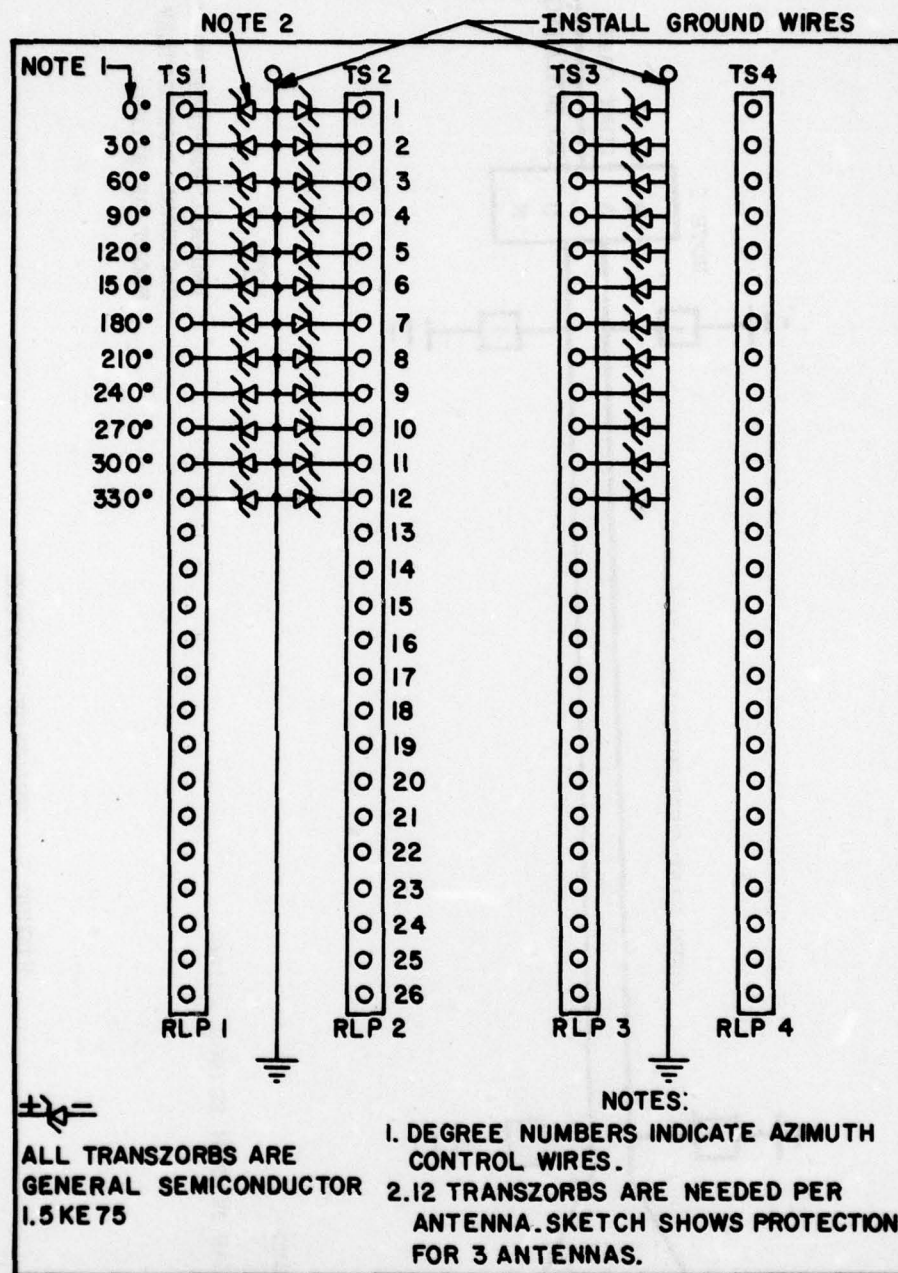
FIGURE 4. MATRIX CONTROL DIODE PROTECTION

3.1.5 RLP antennas 7, 8 and 9 were checked for lightning protection. These antennas are connected to the Scope Control system. Radio maintenance personnel indicated a considerable number of diode failures were occurring in the matrix control rack during lightning storms. Diode failure usually resulted in a continuous rotation of the affected RLP antenna. To eliminate this problem, the diodes were relocated to removable PC boards. The PC boards are usually removed during lightning storms. The diodes act as isolating devices and are used only for azimuth display purposes on the matrix control rack. Further inspection revealed diode failure only on RLP antennas 7 and 8. The remote control cables leading from each antenna to the interior of the building were inspected. Remote control cables for antennas 7 and 8 were unshielded. Antenna #9 had a shielded remote control cable. It is evident that in this case a shielded cable does provide protection from lightning induced voltages.

4.1.10 Additional surge protection devices should be installed on control lines of the RLP antennas. A "TransZorb" (or equal transient suppressor) should be installed between each control wire and ground at the receiver building termination. "TransZorb" is manufactured by General Semiconductor Industries Inc., Tempe, Arizona. Model 1.5 KE 75 is recommended. (See Figure 4 for typical installation.)
